**The Galloway Picts Project:  
Excavation and Survey of Trusty's Hill**

**Summary Report**

**Project Number:** 3309

**Date:** 24/10/2012

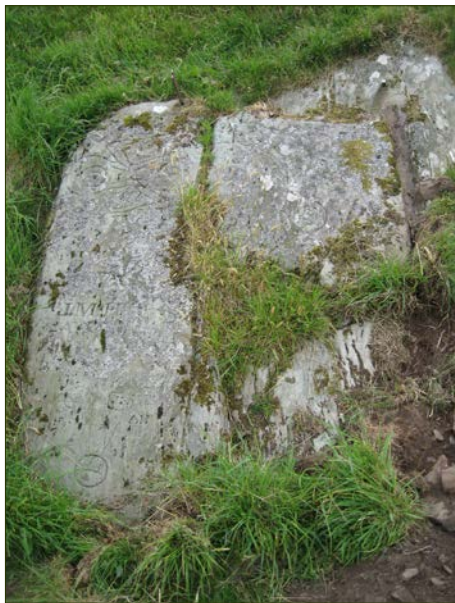
*Plate 1: Pictish Inscribed Stone.*

Trusty's Hill, located just outside Gatehouse of Fleet (Illus 1) is conspicuous amongst the hillforts of Galloway in that it contains a Pictish inscribed stone, depicting a 'z-rod and double disc' symbol and a 'sea beast and sword' symbol (Plate 1). These Pictish Carvings are unique in south-west Scotland and has, until now, made Trusty's Hill one of the most enigmatic archaeological sites in Scotland.

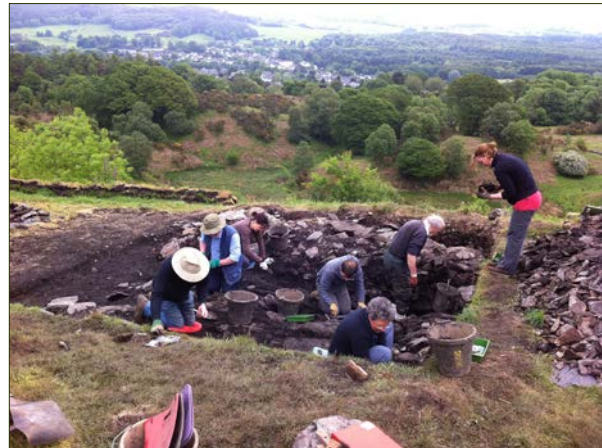
*Plate 2: Volunteers excavating the vitrified rampart and associated occupation deposits at Trusty's Hill.*

The archaeological excavation was undertaken by 65 volunteers in collaboration with GUARD Archaeology Ltd (Plate 2). A daily guided tour was promoted through posters distributed across the region and further afield, and a project web site, [www.gallowaypicts.com](http://www.gallowaypicts.com), was set up prior to the excavation and continues to be updated. A total of 184 visitors were given guided tours during the excavation. A further 14 visitors made their way to the site during the subsequent laser scan survey. The artefacts from the excavation were presented and explained to 11 Fellows of the Society of Antiquaries of Scotland who visited GUARD Archaeology Ltd's Finds Laboratory on Saturday 9 June, the weekend immediately after the completion of the excavation. The interim results of the excavation were presented at the DGNHAS 150th Anniversary Conference in Dumfries on Saturday 8 September,

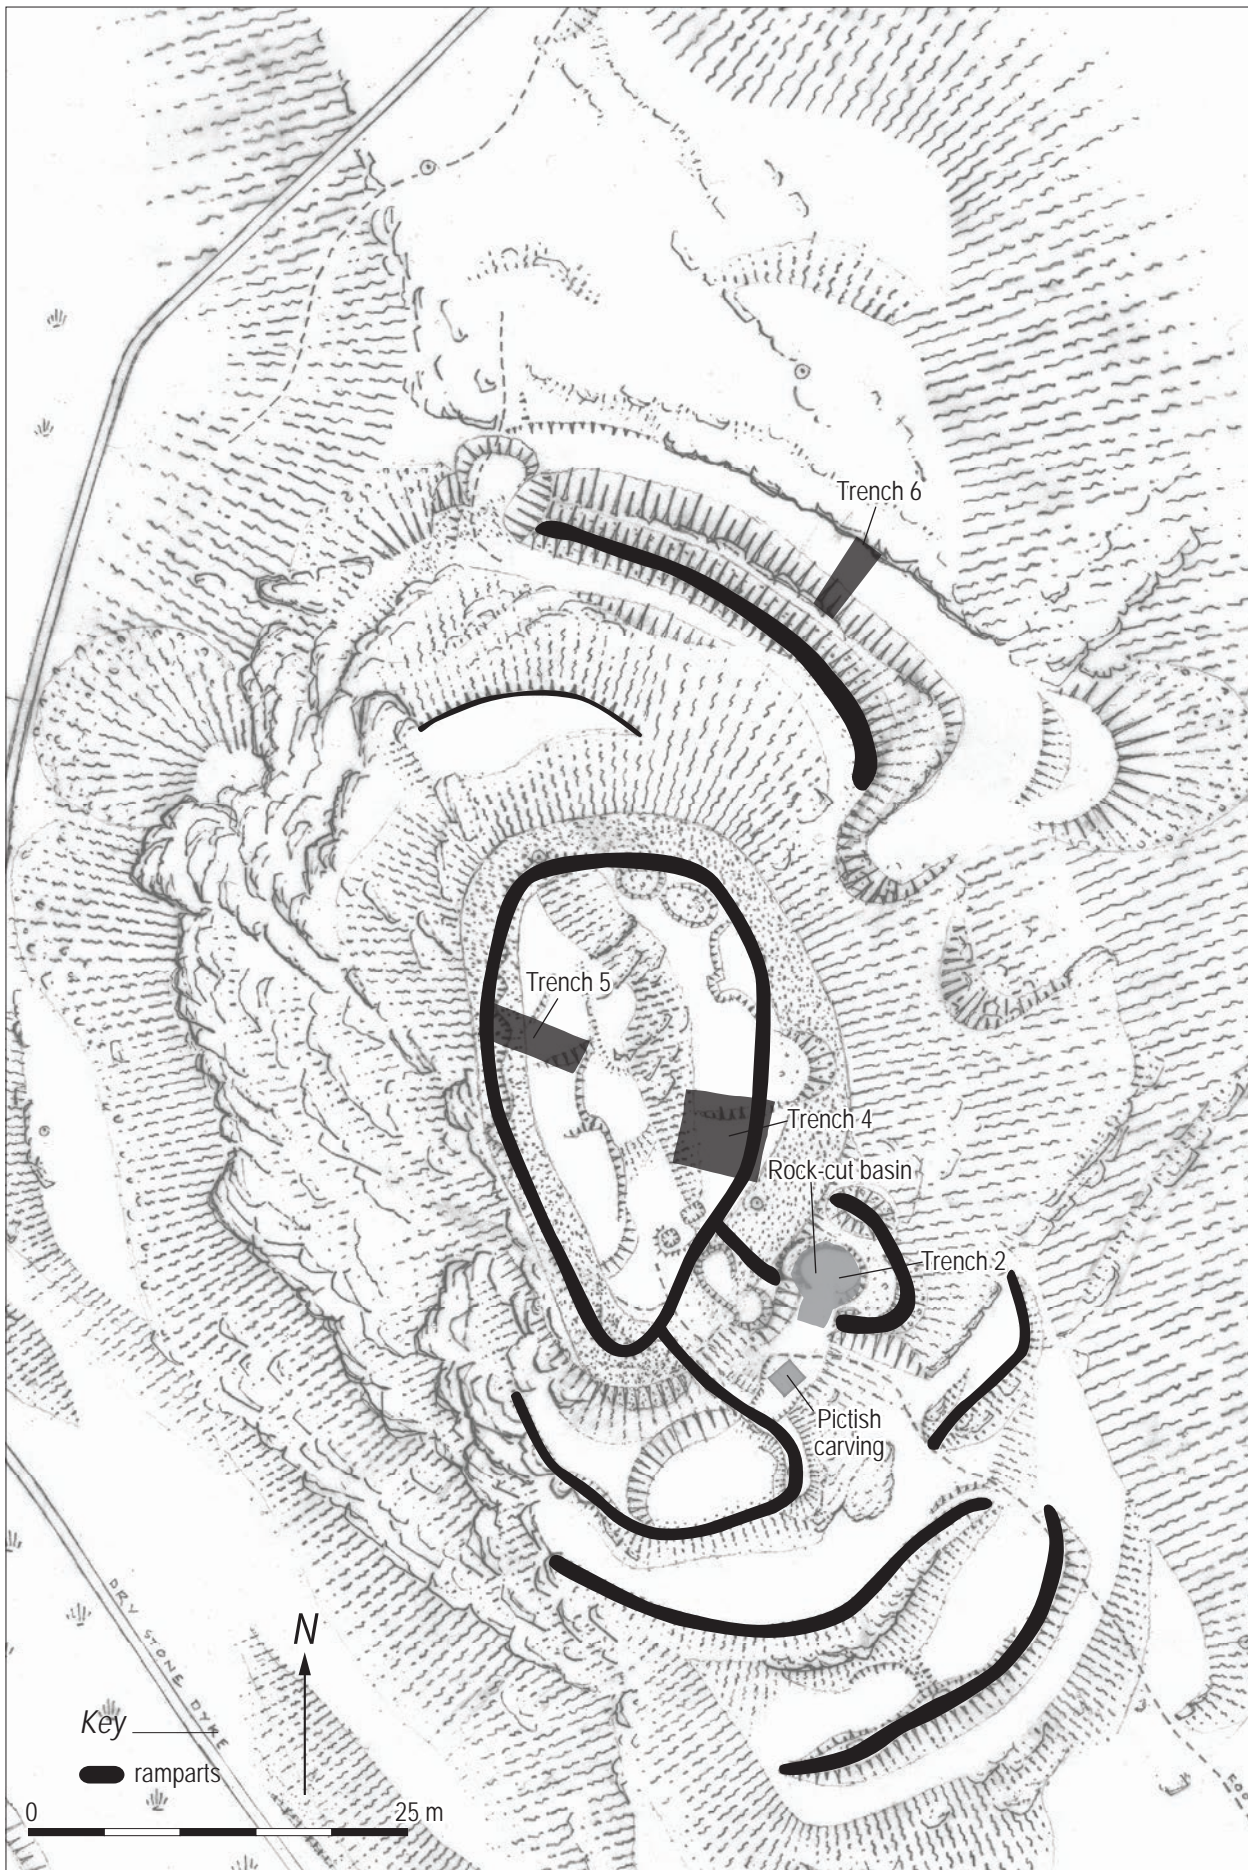
Illustration 2: Nucleated Fort layout of Trusty's Hill.

The Galloway Picts Project got underway with a GPS topographic survey of Trusty's Hill by the Royal Commission on the Ancient and Historical Monuments of Scotland (RCAHMS), producing for the first time a measured detailed plan of this Scheduled Ancient Monument, necessary preparation for the subsequent excavation to allow accurate recording of the trenches and the features. The topographic survey updates the measured sketch plan that Thomas produced during the previous excavation, providing a modern accurate plan of the site that demonstrates that Trusty's Hill comprises a fortified citadel around the summit of a craggy hill with a number of lesser enclosures looping out from the summit along lower lying terraces and crags of the hill (Illus 2). It therefore recognisably conforms to the definition of a nuclear fort, a type of fortified, high status settlement that emerged in Scotland in the post-Roman period.

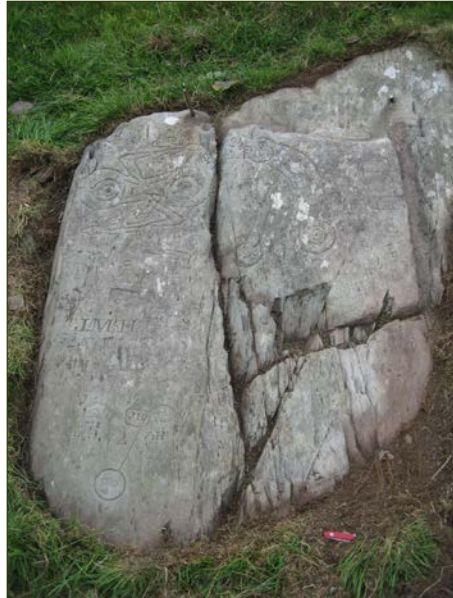
*Plate 3: Pictish Inscribed Stone after cleaning.*

The results of the cleaning (Plate 3) and laser scan survey of the inscribed stone, undertaken subsequent to the excavation by the Centre for Digital Documentation and Visualisation LLP, still requires detailed specialist examination, but ogham is clearly not apparent along the southern edge of the inscribed stone (Illus 4). While this is in some ways disappointing, it nonetheless offers a correct and comprehensive depiction of the inscribed stone at Trusty's Hill for the first time and corrects several more discrepancies from previous depictions.
